POPPLETON HISTORIC STUDY

1101-1131 W. Mulberry Street

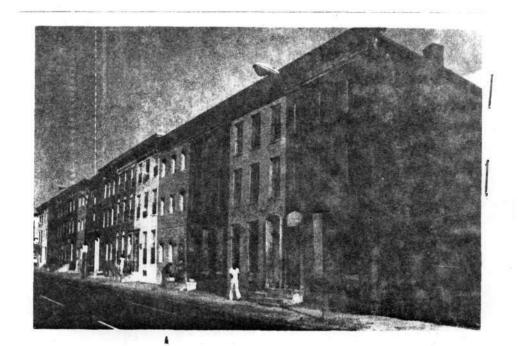
A long terrace of large houses built between 1869 and 1876. Many are vacant (1131, 1129, 1127, 1119) and the others are grossly rundown due to the highway development, years of heavy one-way traffic on Mulberry Street, which has relatively narrow sidewalks, and, no doubt, other causes. When Mulberry Street becomes a service road, these could be rehabilitated.

The row faces the Franklin-Mulberry corridor and expressway. It needs redesign. If a strip were heavily planted between Mulberry and the expressway, this would assist the retention of these houses.

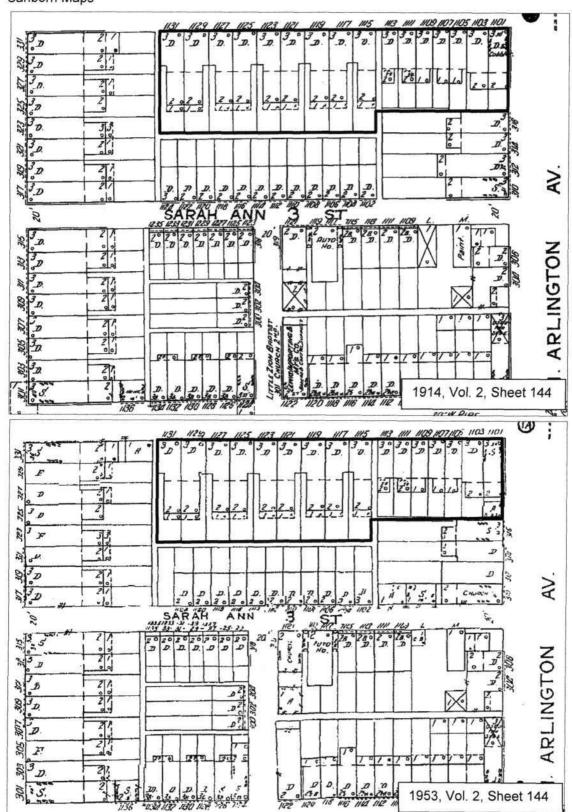
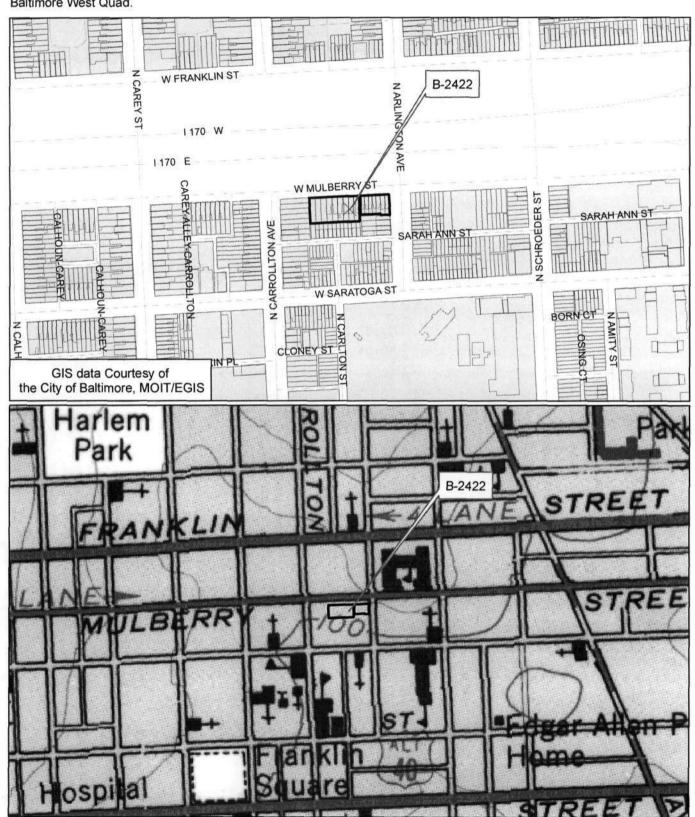
B-2422 1101-1131 W. Mulberry Street Block 0155 Lots 050-035 Baltimore City Baltimore West Quad.

DEMOLISHED
